DEVICE FOR MANUFACTURING LITHOGRAPHIC PRINTING PLATE AND METHOD FOR DETECTING INSULATION FAILURE SPOT IN THE DEVICE

Patent number: JP2003019876
Publication date: 2003-01-21
Inventor: TSUGE TATSUO
Applicant: FUJI PHOTO FILM CO LTD
Classification:
- International: B41N3/03; C25D11/04; G01R31/02
- european:
Application number: JP20010205963 20010706
Priority number(s): JP20010205963 20010706

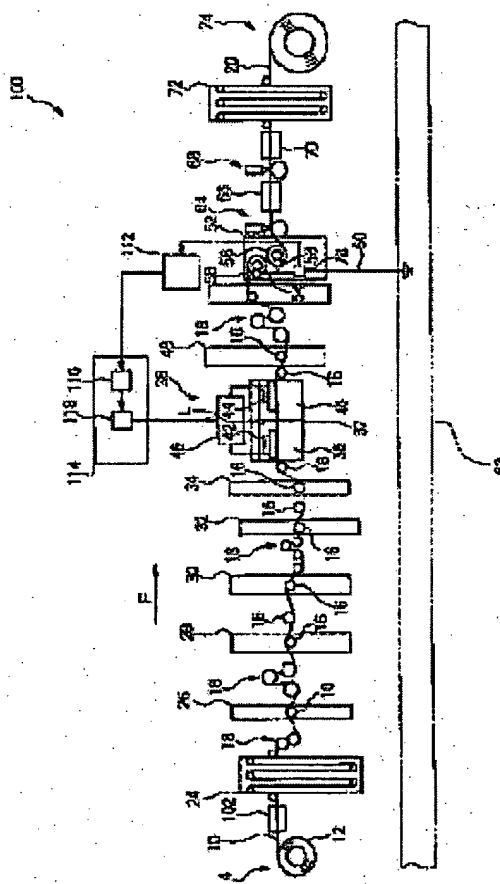
SOLUTION: In an alarm generating part 116 of a process computer 114, an upper limit threshold value and a lower limit threshold value of leakage current, can be set respectively. On the other hand, the process computer 114 calculates the upper limit threshold value and the lower limit threshold value respectively on the basis of the set value or the like of the electrolytic current, prior to the start of an electrolytic treatment to an aluminum web 10 or in a timely manner by which electrolytic treatment conditions are changed. Further, the calculated upper limit threshold value and the lower limit threshold value are set at the alarm generating part 116. The alarm generating part 116 outputs an alarm signal and the measurements of the leakage current to an alarm processing part 118 of the process computer 114 when the leakage current measured by a current measuring apparatus 76 exceeds the upper limit threshold value and reaches the lower limit threshold value or below respectively.
